TEST REPORT

Sensitive Strain Gauge Testing of Large-Diameter Culvert Rehabilitation

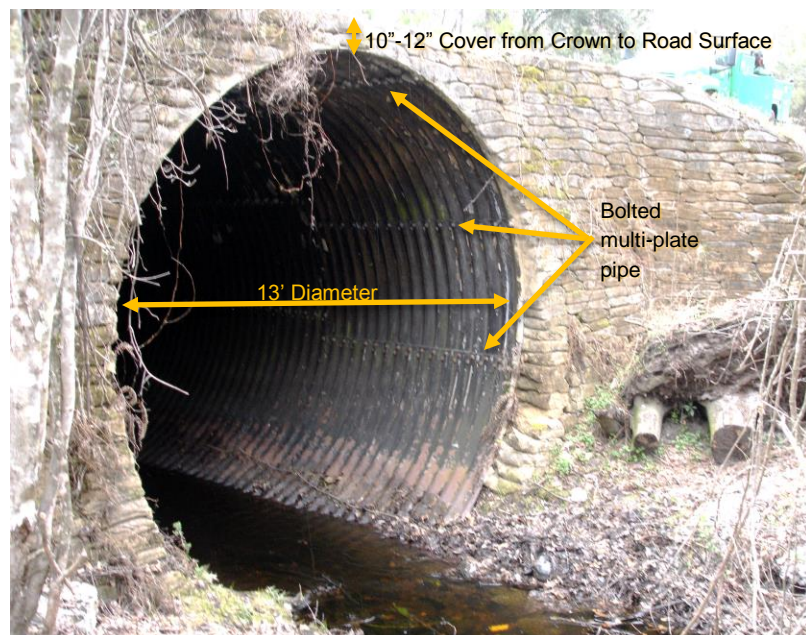
Figure 1: Florida State Route 16 Culvert Attributes

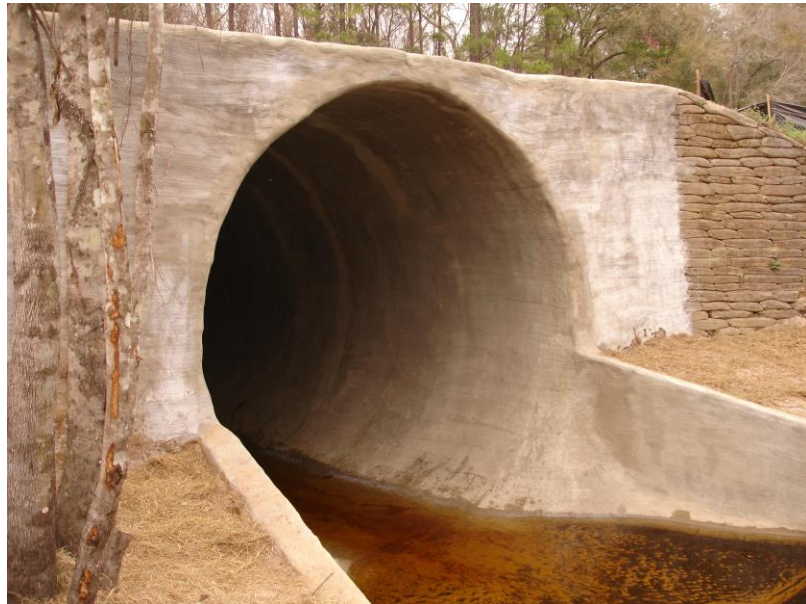
Figure 2: Fully structural, smooth, watertight rehabilitated culvert

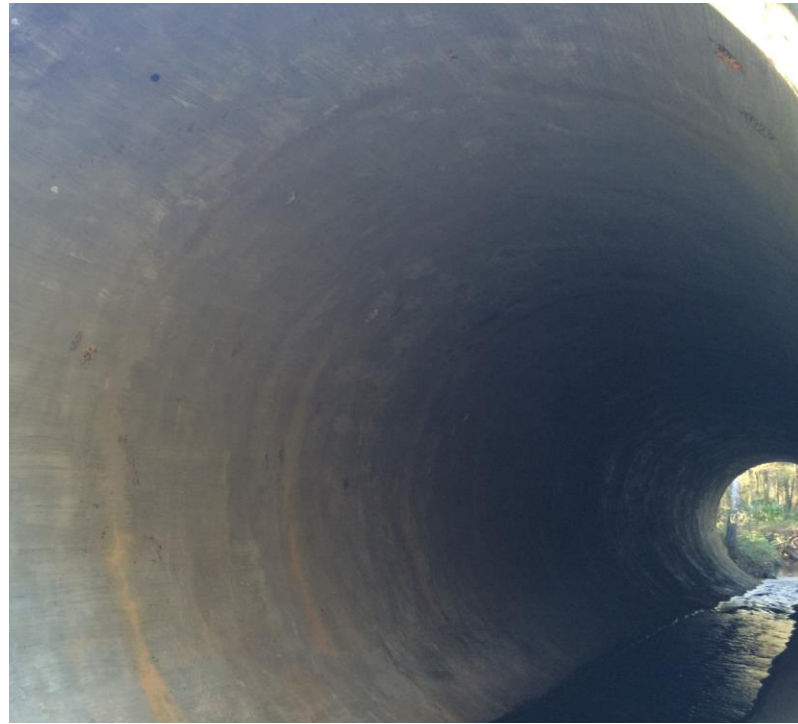
In January 2016, an initial walkthrough was conducted. Visually, the rehabilitated culvert still looked brand new with no visible wear, voids, or fractures.

Figure 3: Six-year visual inspection - No visible wear, voids, or fractures

The like-new appearance of the repaired culvert was good evidence in itself—the total absence of fractures from heavy live loads proved that the PL-8000 lining was holding up to traffic loads.

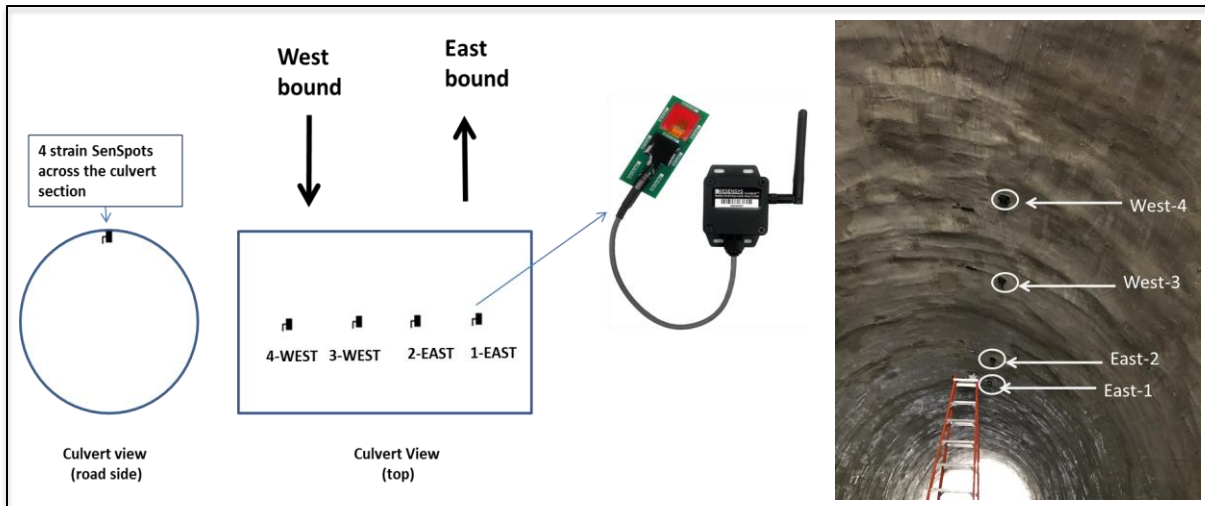
On November 21, 2016, a Resensys team installed four highly sensitive SenSpot sensors evenly spaced along the 96-foot long culvert crown (top inner surface), plus a data logger to record data from the sensors.

Figure 4: Placement of strain gauges within pipe

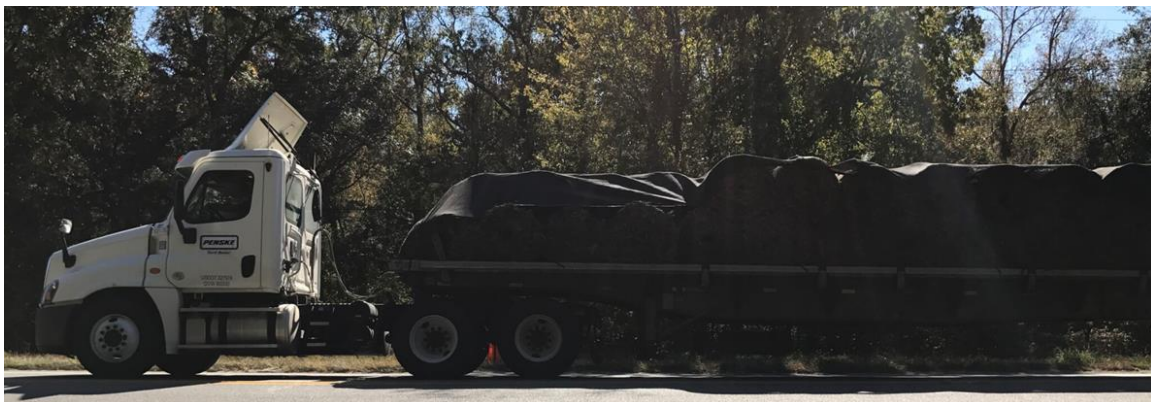
On November 22, 2016, the culvert was deliberately subjected to extreme load testing. A loaded 18-wheeler, with verified weight of 83,620 pounds, was contracted to drive over the culvert in both directions, stopping each way with cab axles, and then trailer axles, directly over the crown of the culvert. Axle alignment was verified visually, with an alignment tool, and by monitoring the strain gauges during truck movement—basically,

Figure 5: Strain testing with loaded 83,620 pound 18-wheeler

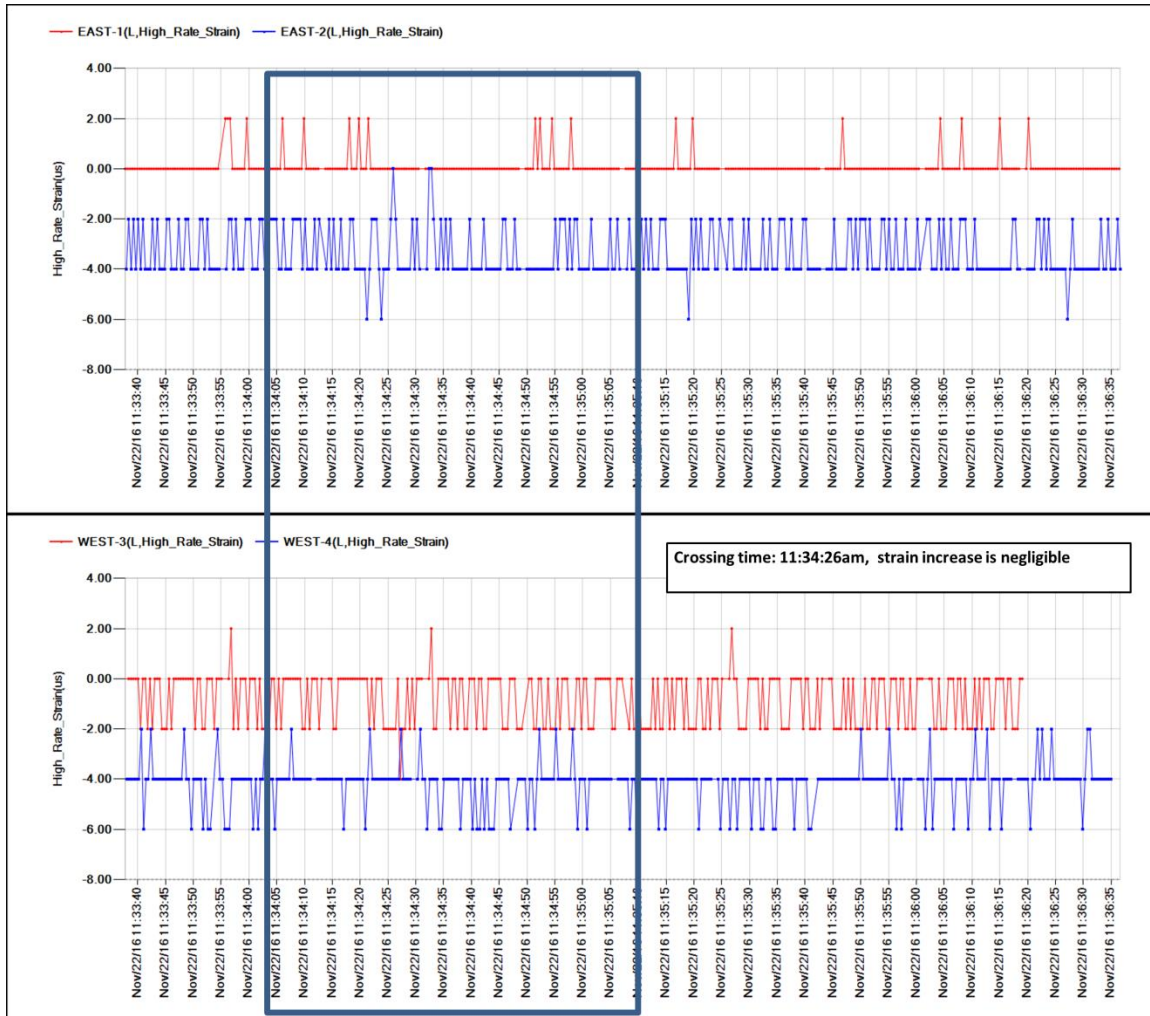
The resulting sensor data showed that the loading effects of the truck weight on the rehabilitated SR 16 culvert were negligible. According to the Resensys report, “During truck tests of November 22, 2016, very little strain change was observed and as a result, it is logical to assume that the structure can carry load up to (and possibly even larger than) the weight of the truck used when the tests were conducted.”

Figure 6: Load Rating Test 1 - Truck moved east-bound with speed of 3 MPH. No significant strain was observed.

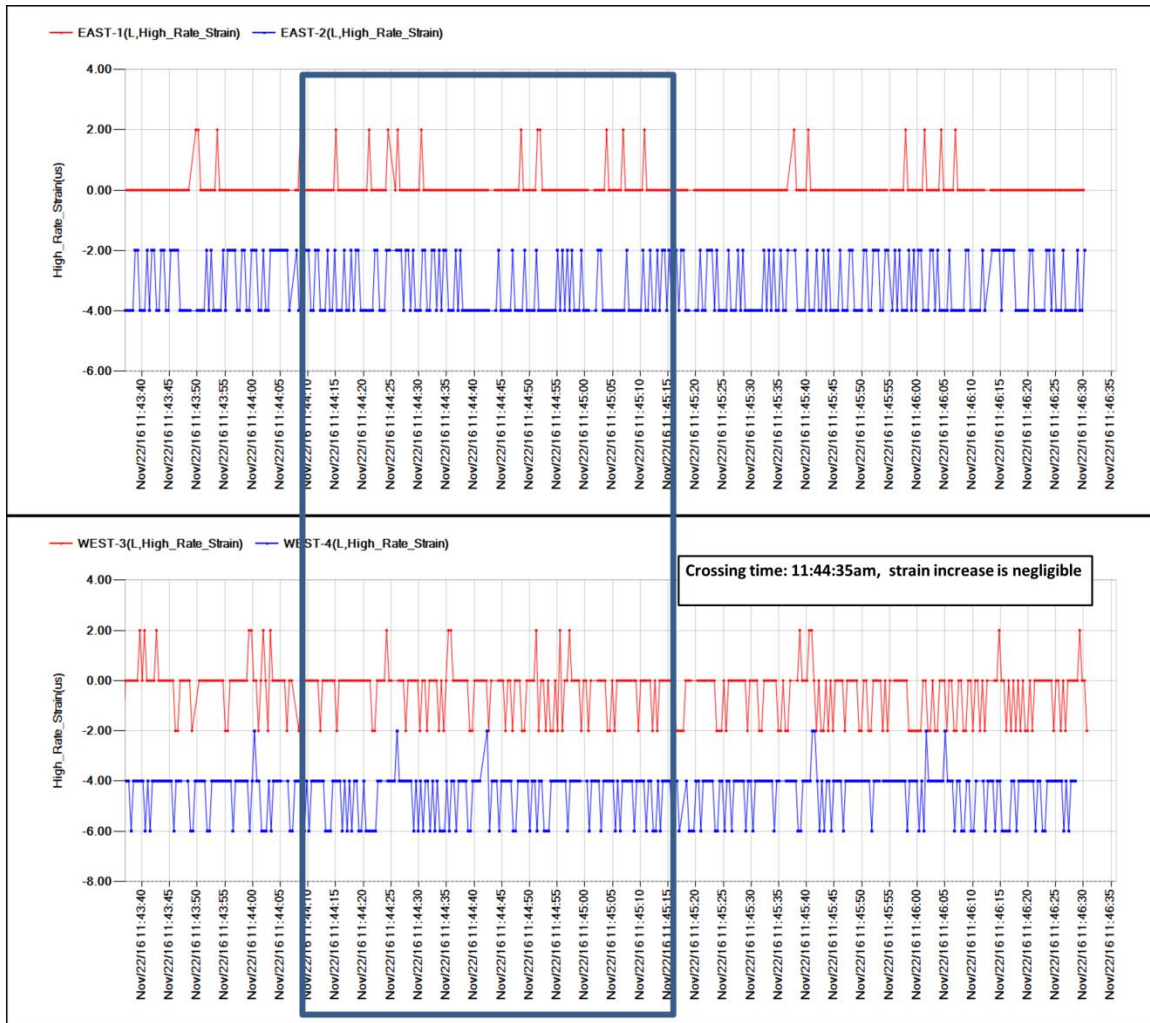
Figure 7: Load Rating Test 2 - Truck moved west-bound with speed of 3 MPH. No significant strain was observed.

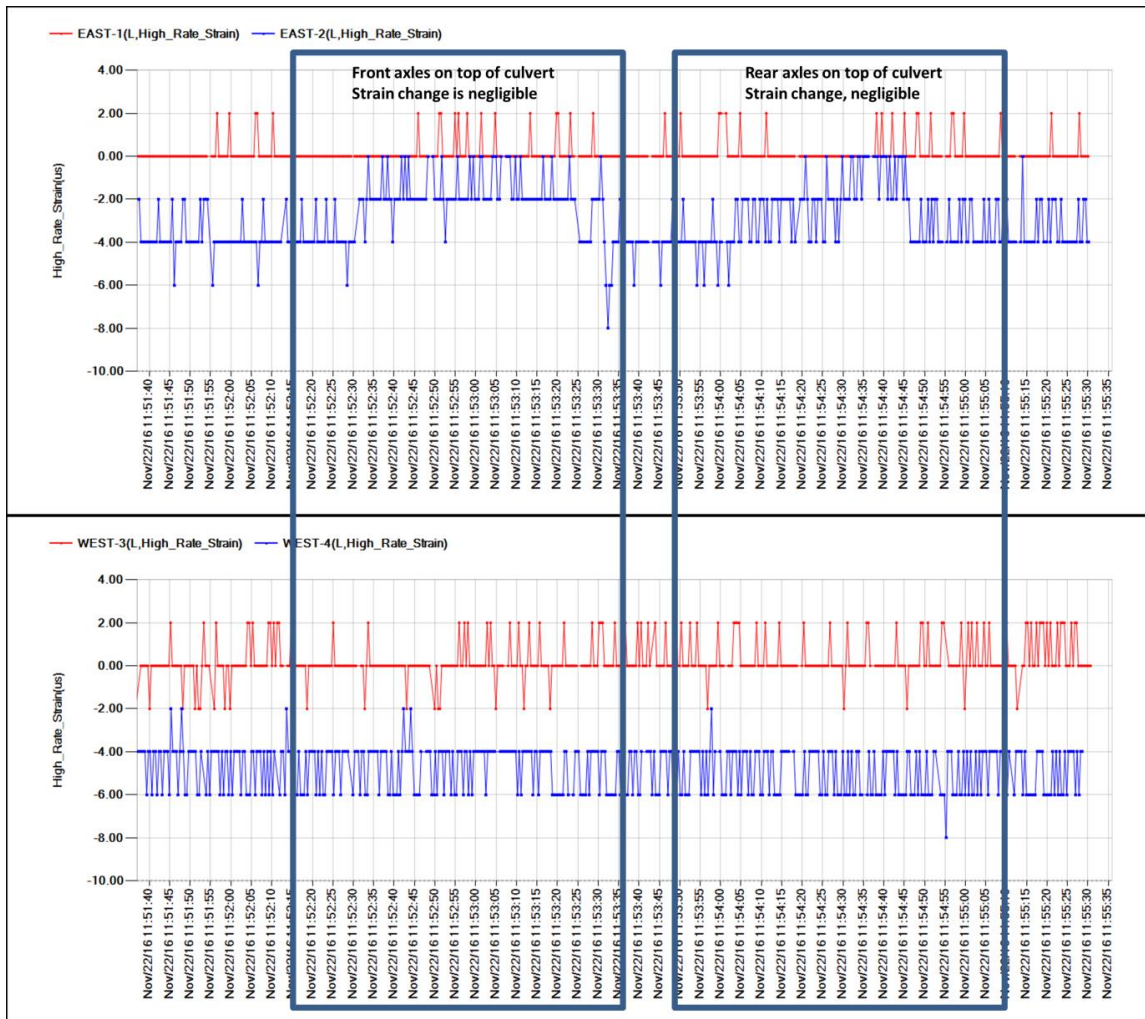
Figure 8: Load Rating Test 3 - Truck moved east-bound, stopping at 11:52 a.m. EST with front axles on top of culvert, and at 11:54 a.m. EST with rear axles on top of culvert. East-2 strain SenSpot sensor shows 2-4 microstrain increase in strain and for other three strain SenSpot sensors, no significant change in strain was observed.

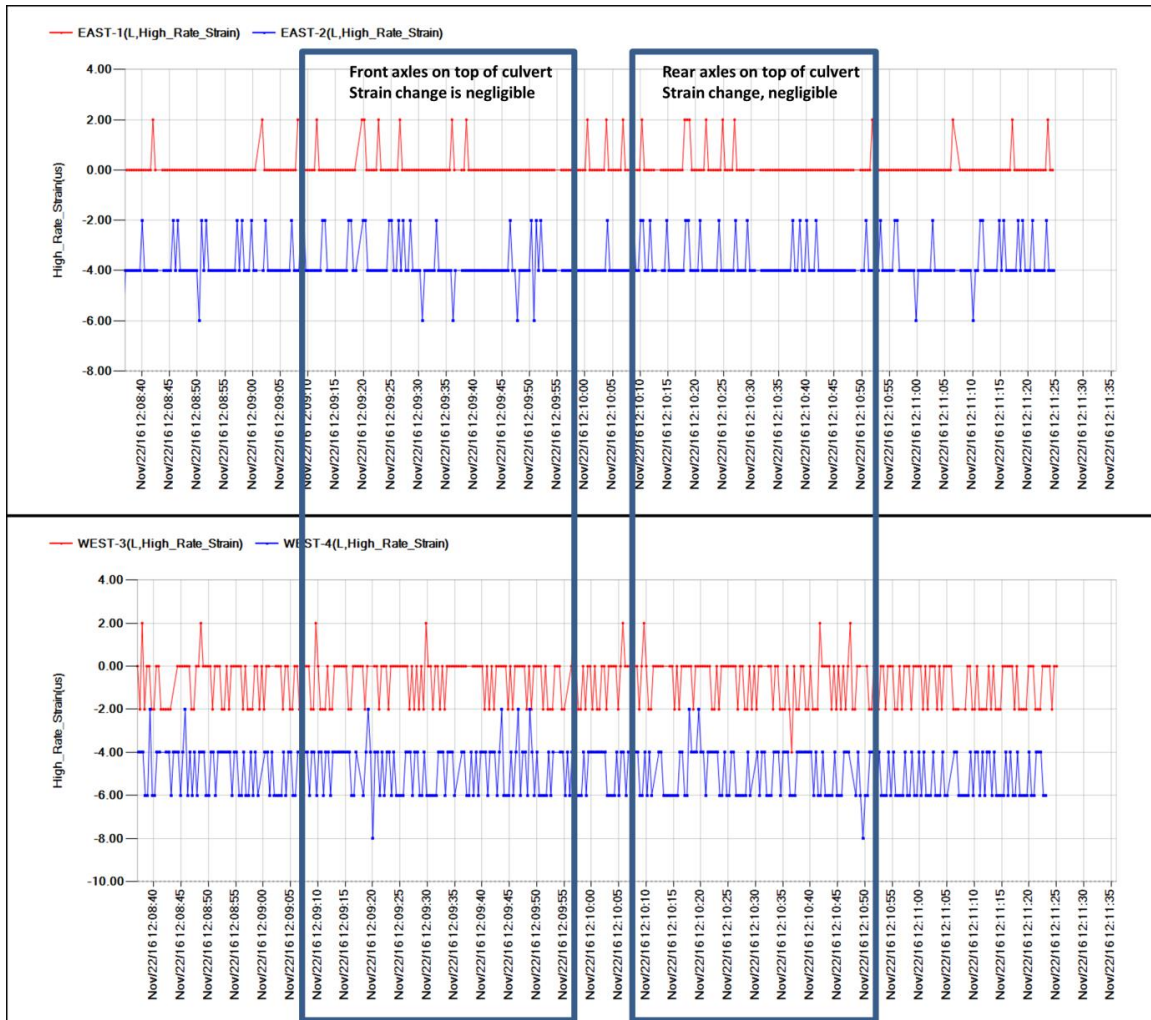
Figure 9: Load Rating Test 4 - Truck moved west-bound, stopping with front axles on top of culvert at 12:09 p.m. EST, and rear axles on top of culvert at 12:10 p.m. EST. No significant change in strain was observed.

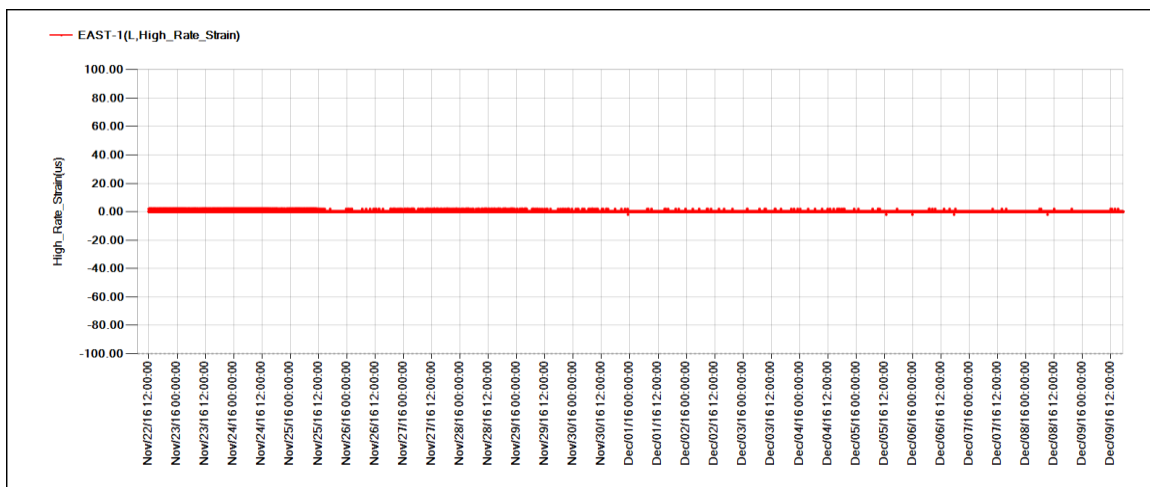
“Monitoring strain at four locations across the section of the culvert from November 22, 2016 until December 9, 2016 shows that no strain change has been caused by traffic (live load). Generally, live load (e.g., passing of heavy trucks) can result in transient (spike-like) strain change events. However, inspection of the strain graphs during the reporting period does not show any transient strain change. This implies the safe load carrying capacity of the structure under the existing traffic conditions. In addition, this observation is consistent with the truck test loads conducted on November 22, 2016.”

Figure 10: Continuous Strain Monitoring - Readings of South SenSpot installed on East Bound of the culvert (East-1)

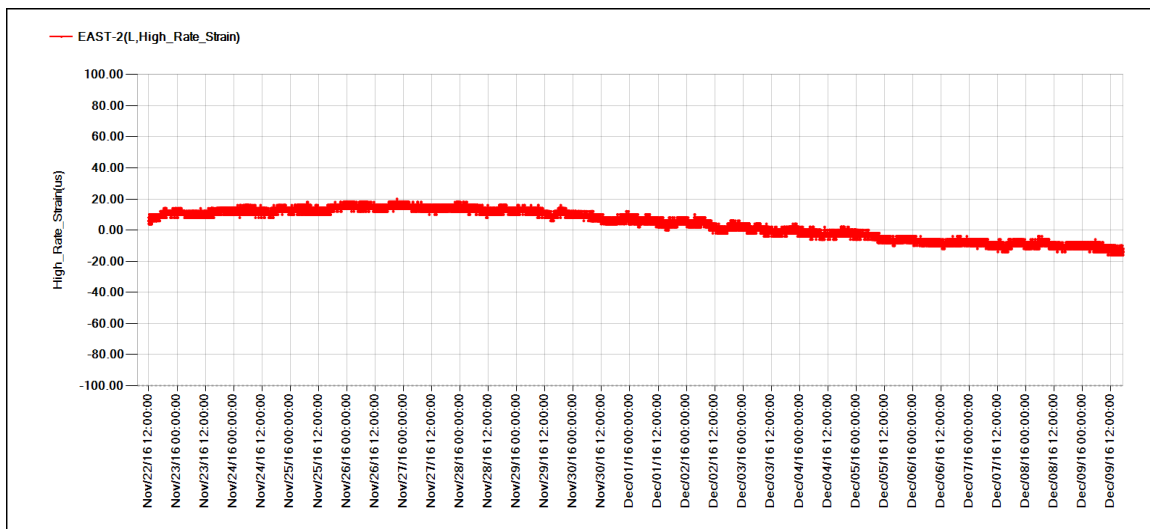
Figure 11: Continuous Strain Monitoring - Readings of North SenSpot installed on East Bound of the culvert (East-2)

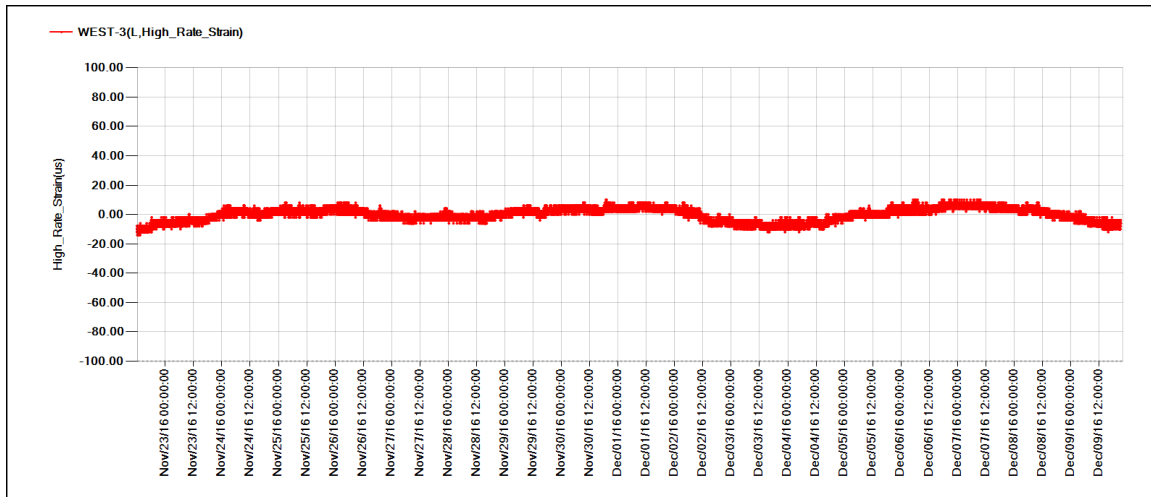
Figure 12: Continuous Strain Monitoring - Strain readings of South SenSpot installed on West Bound of the culvert (West-3)

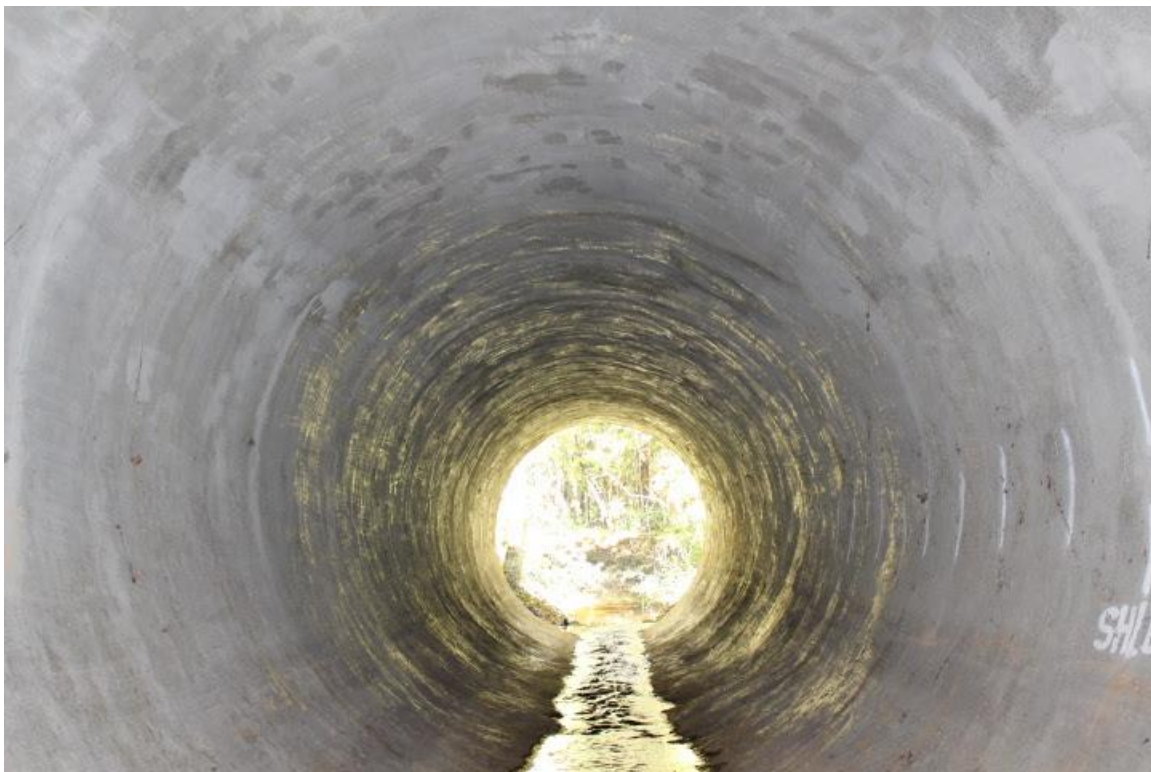
Figure 14: November 2016 - Photo of structurally sound rehabilitated pipe, taken during strain gauge testing.
