Tests of Corroded Steel Pipes Externally Wrapped with QuakeWrap®

Test Date: July 2013
Testing Lab: Polymer Technology Center
Gedung 460, Kawasan Puspiptek
Tangerang-Banten 15314 INDONESIA

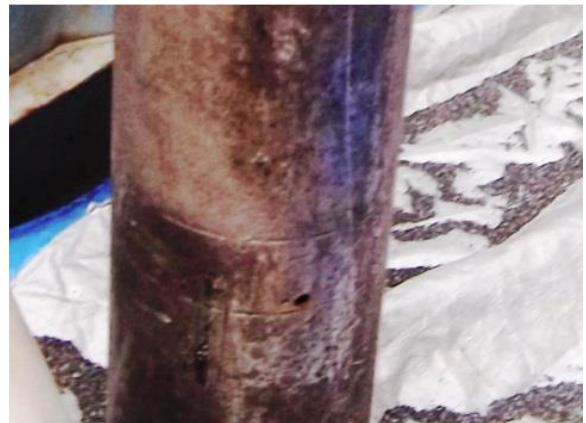
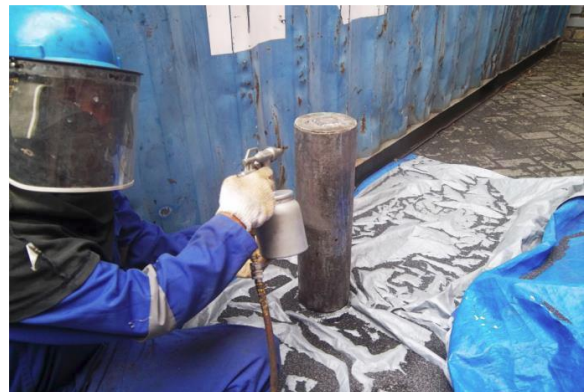
1. A steel pipe segments with diameter of 5 inch (127 mm) and thickness of 0.118 inch (3 mm) was selected. A 20-mm (0.787-inch) diameter hole was drilled in the pipe to simulate corrosion damage.
2. The pipe surface was sand blasted to meet the Swedish Standards SA 1 (ISO SA 1) for surface preparation. This produced a near white surface.

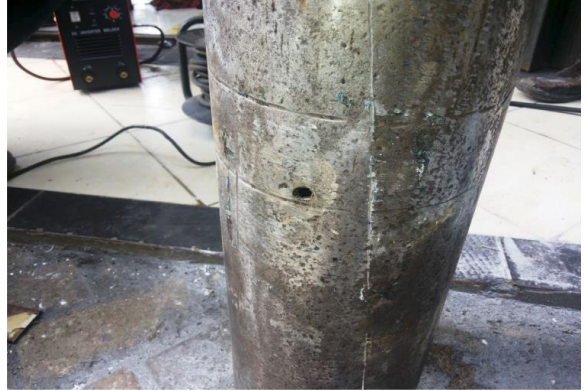
3. The finished pipe after sandblasting is shown here.

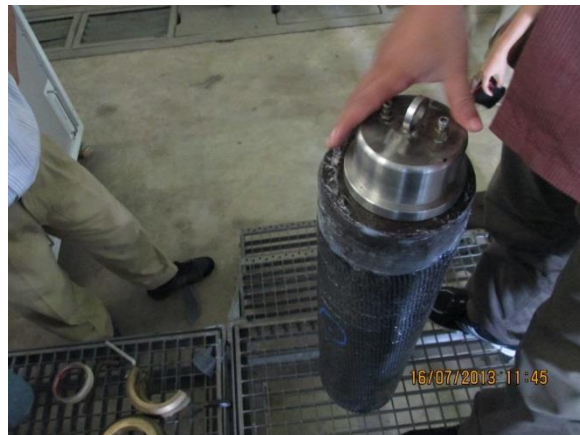
12. The ends of the pipe were capped, sealed and filled water. An initial pressure test was performed to make sure there were no leaks in the system.

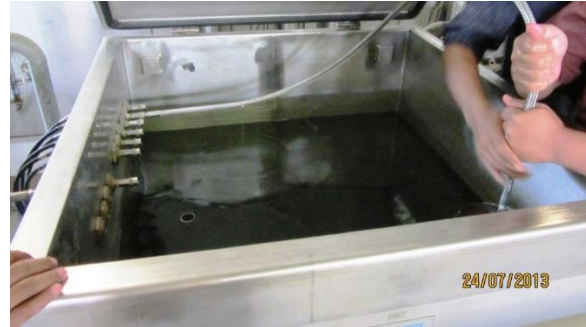
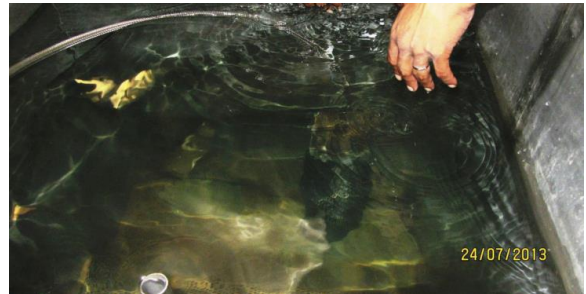
13. For added safety, the pipe test assembly was placed inside a tank containing water.

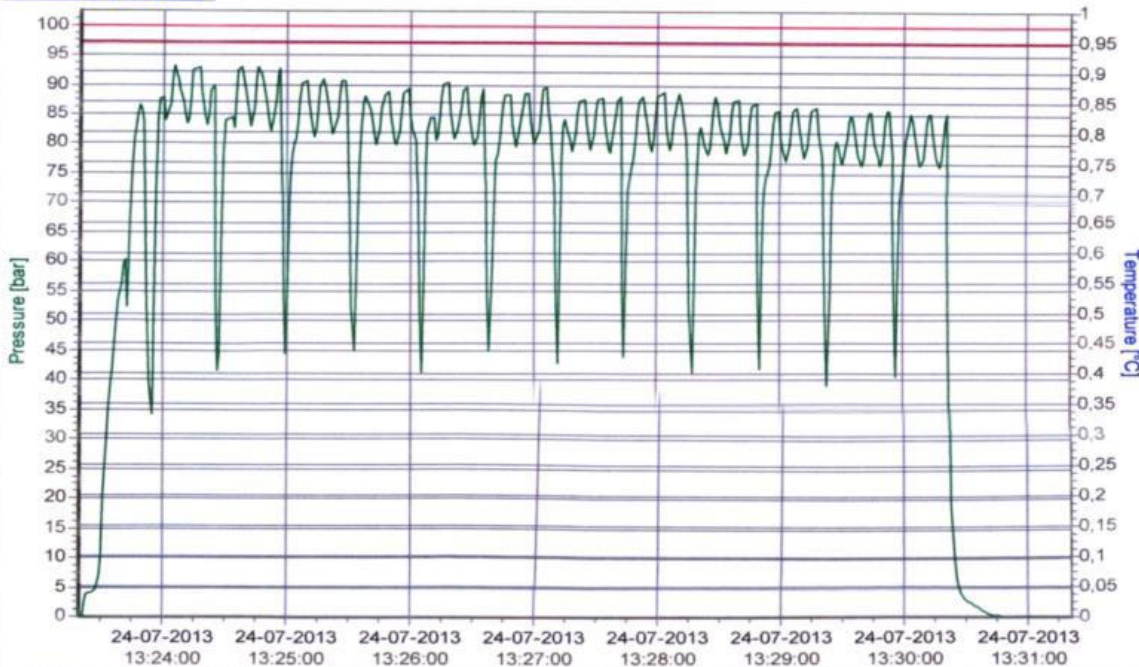
Complete Test View

14. The pipe test pressure was set at 95 bar (1378 psi). The maximum pressure reached in the repaired pipe was 93.1 bar (1351 psi). The complete data collected during the test is shown on the next page.

Operator	abd,
Station	16
Set Pressure	97,90 [bar]
Hysteresis	0,95 [bar]
Alarm limit	1,99 [bar]
Max. Pressure	93,15 [bar]
Leak rate	5

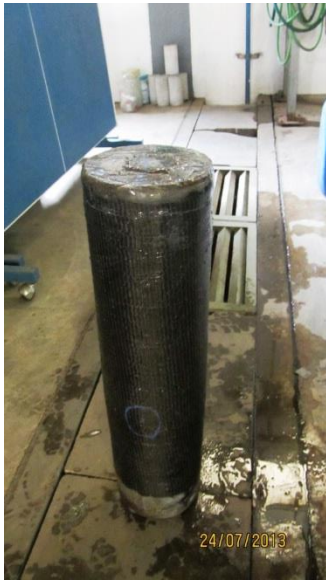
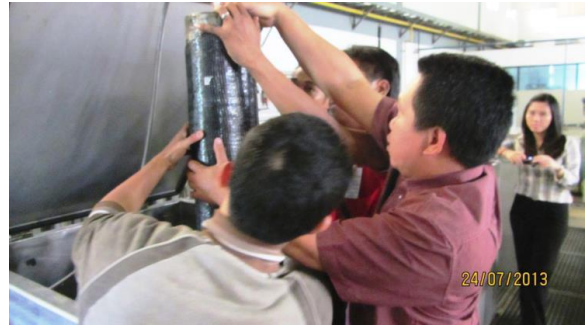
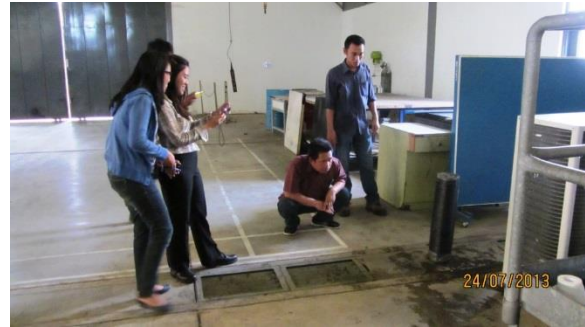
15. These photos show the test specimen at the conclusion of the test with the repair hole location marked. Failure of the specimen was through a small leak at the hole at a pressure of 93.1 bar (1351 psi).
