Custom Biologicals, Inc.

Concrete Testing for Con^{mic}Shield Additive Miami Dade Project 9-26-08

Key Biscayne Manhole Miami-Dade Water & Sewer Authority INSTALLED AUGUST 2001

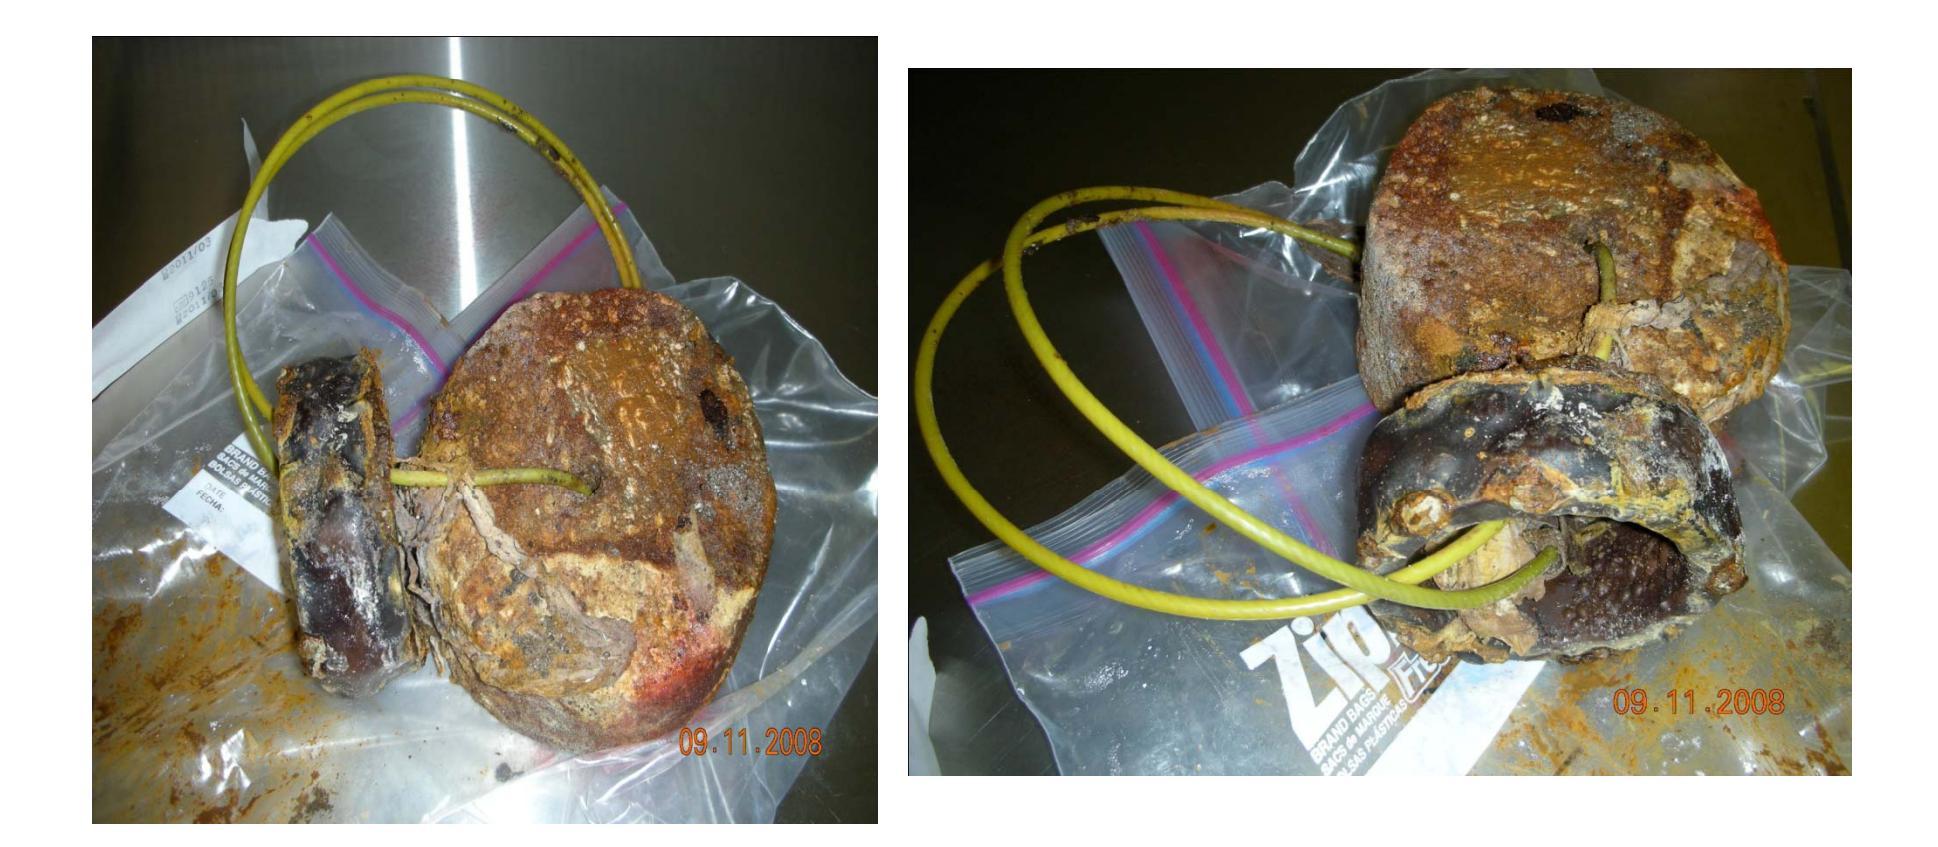
Bright Red indicates pH <5

- 1. The specimen from the Miami-Dade test manhole in service since August 2001 was delivered to our lab on September 11, 2008.
- 2. The surface tested at acidic levels of pH 5 as expected from natural acidic conditions on the slime layer.
- 3. E. Coli and similar bacteria were growing on the organic surface material on the slime layer.
- 4. Thiobacillus Thioxidan bacteria were <u>not</u> present because this bacteria will not grow on organic material such as bio-solids.
- 5. The concrete exposed below the slime layer was undamaged.
- 6. The exposed concrete surface killed the indicator bacteria and therefore tested positive for the presence of Con^{mic}Shield additive.

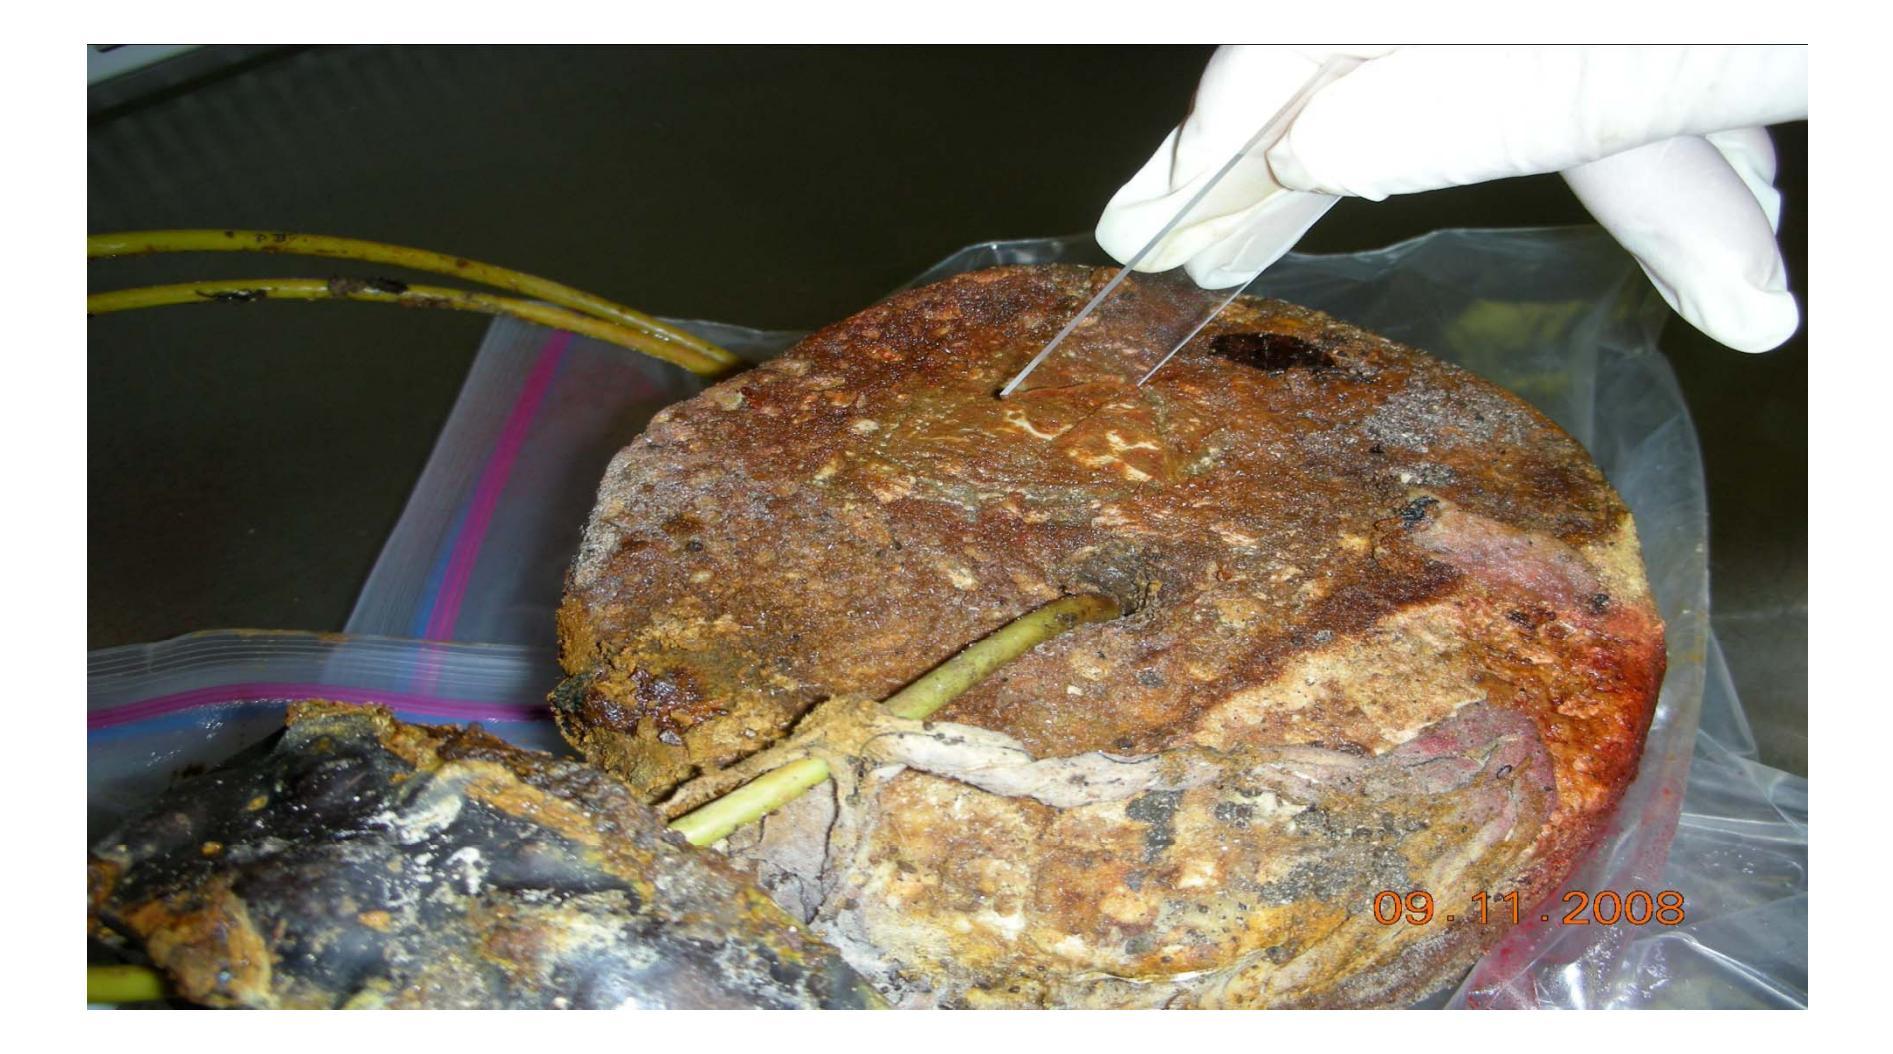
Surface Preparation Surface was scraped with a microscope slide to remove a large

part of the slime layer and allow access to the concrete.

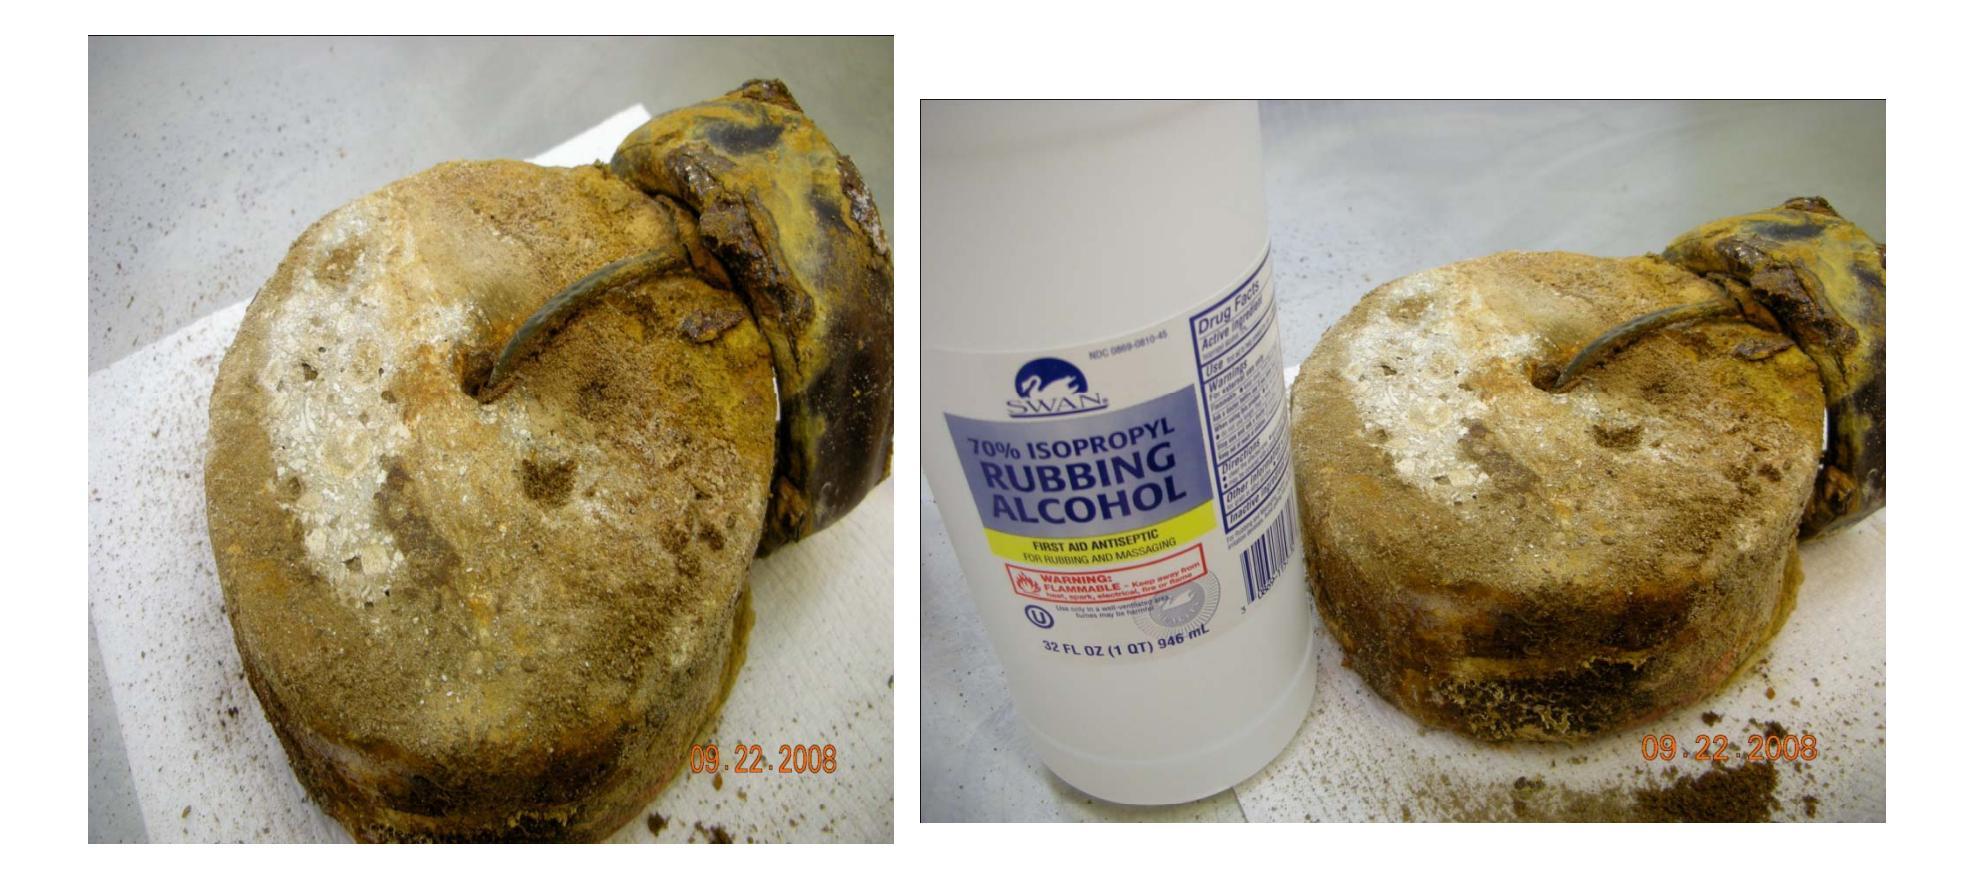
SAMPLE PREPARATION

Sample was dried by removing the moisture from the container. Then, sample was cleaned using an alcohol wash and manual brush.

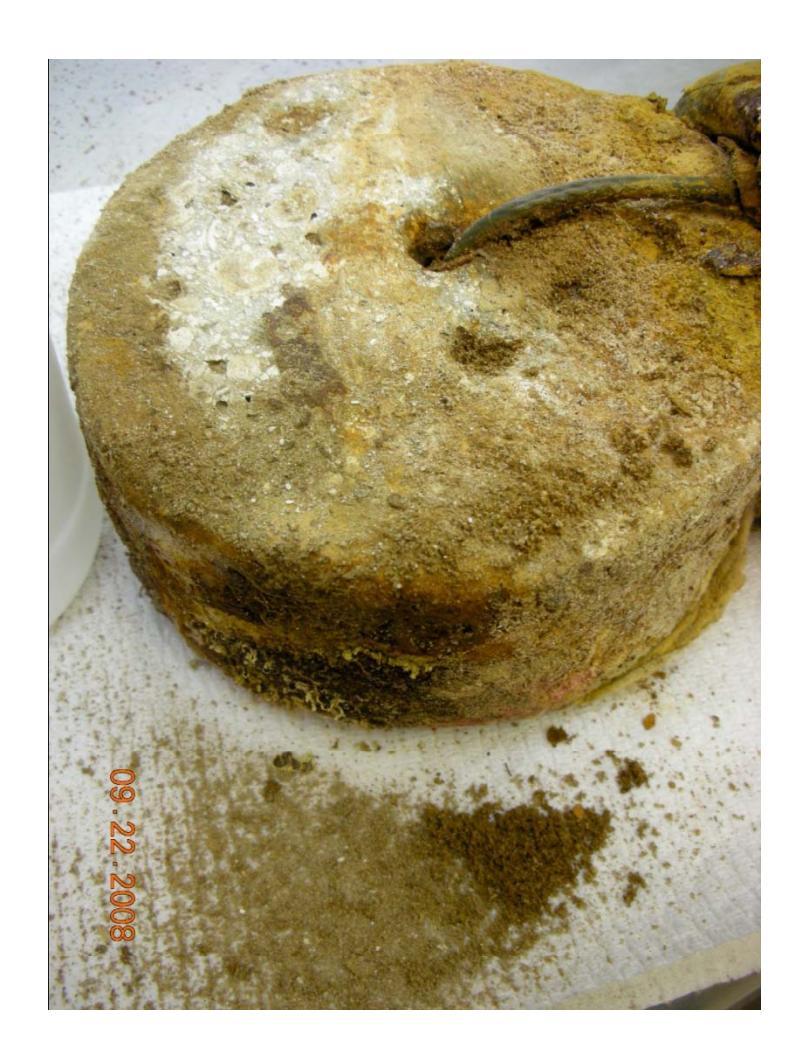
Sample Drying

As the sample dried, debris and slime were easily removed

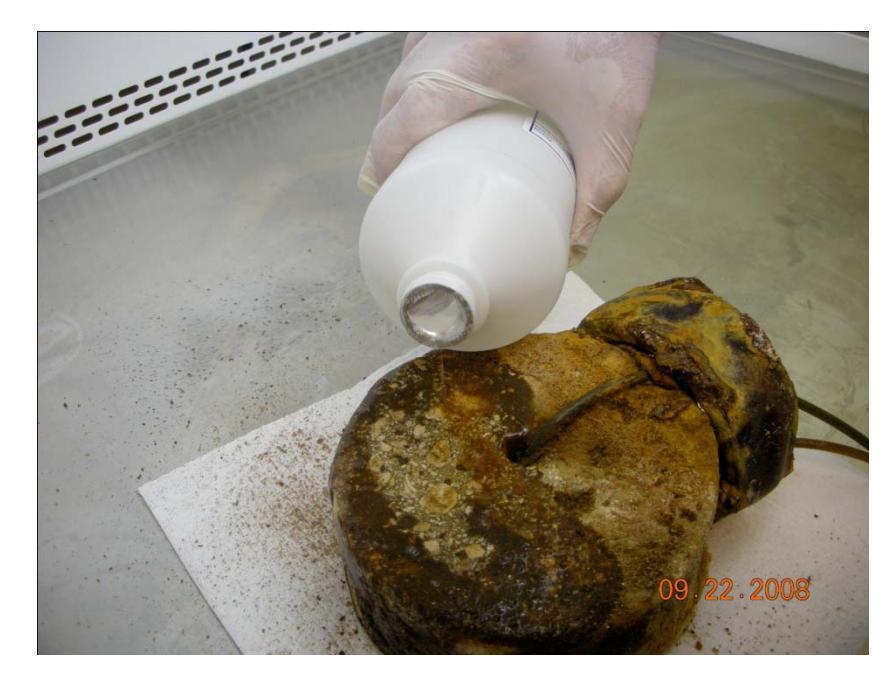
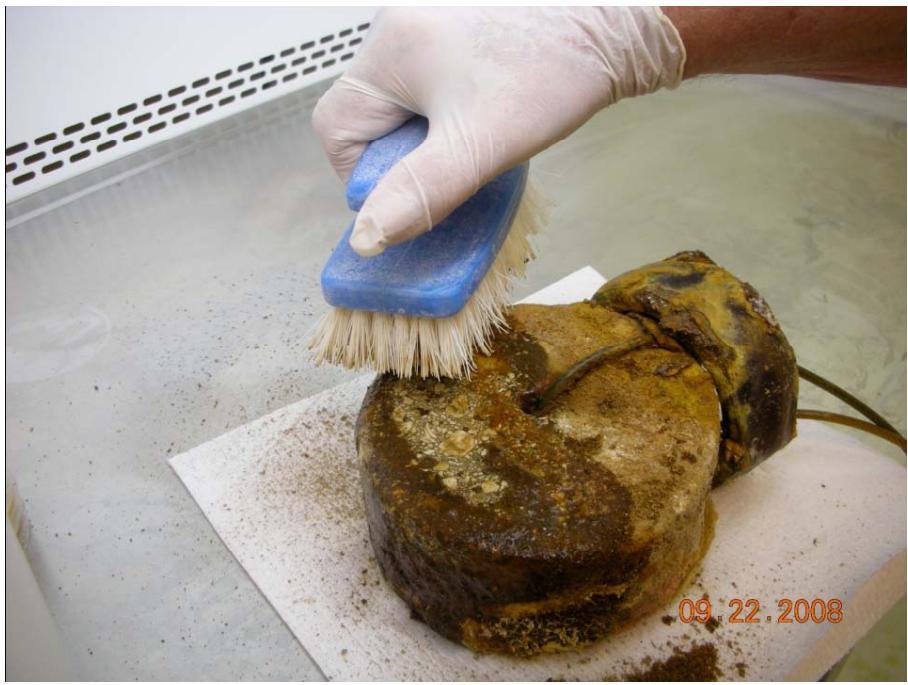
Sample Cleaning

Alcohol wash was repeated and sample was brushed until concrete was fully exposed.

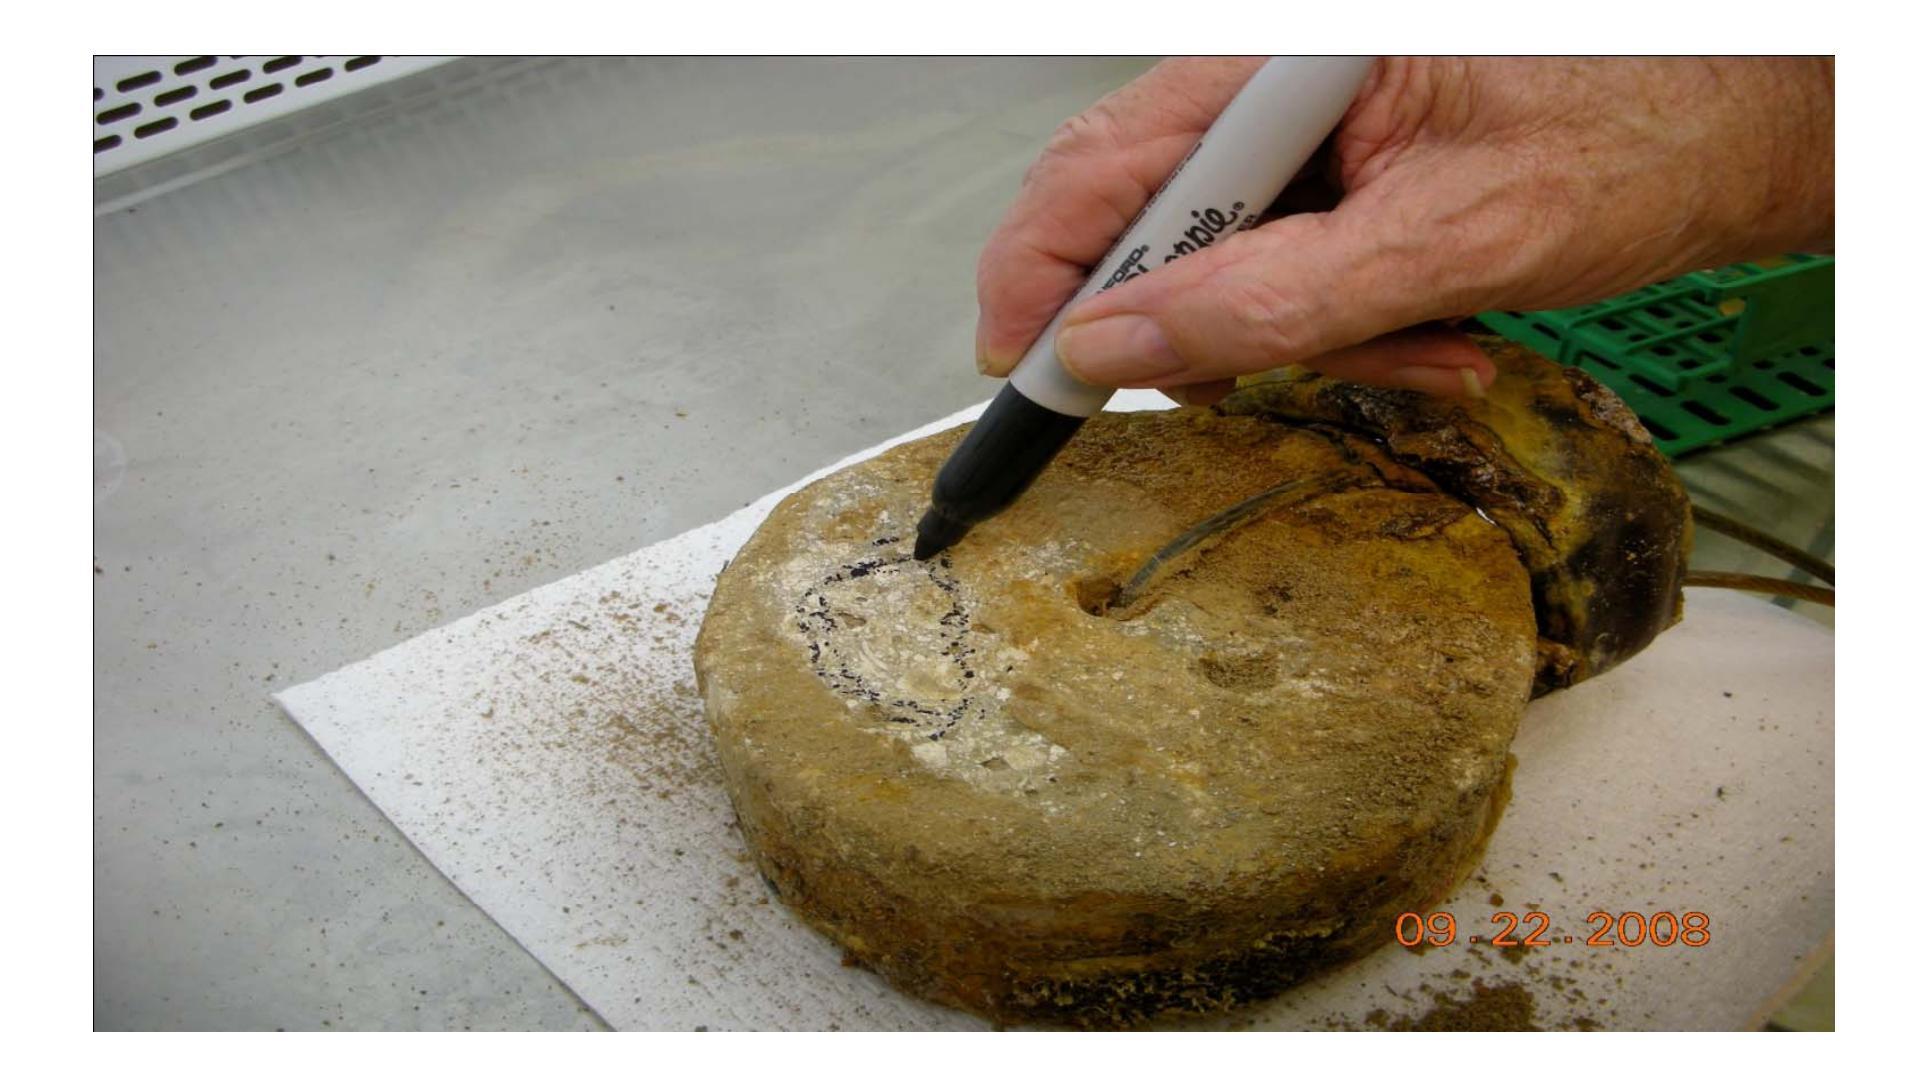
Test Area The test area was clearly marked.

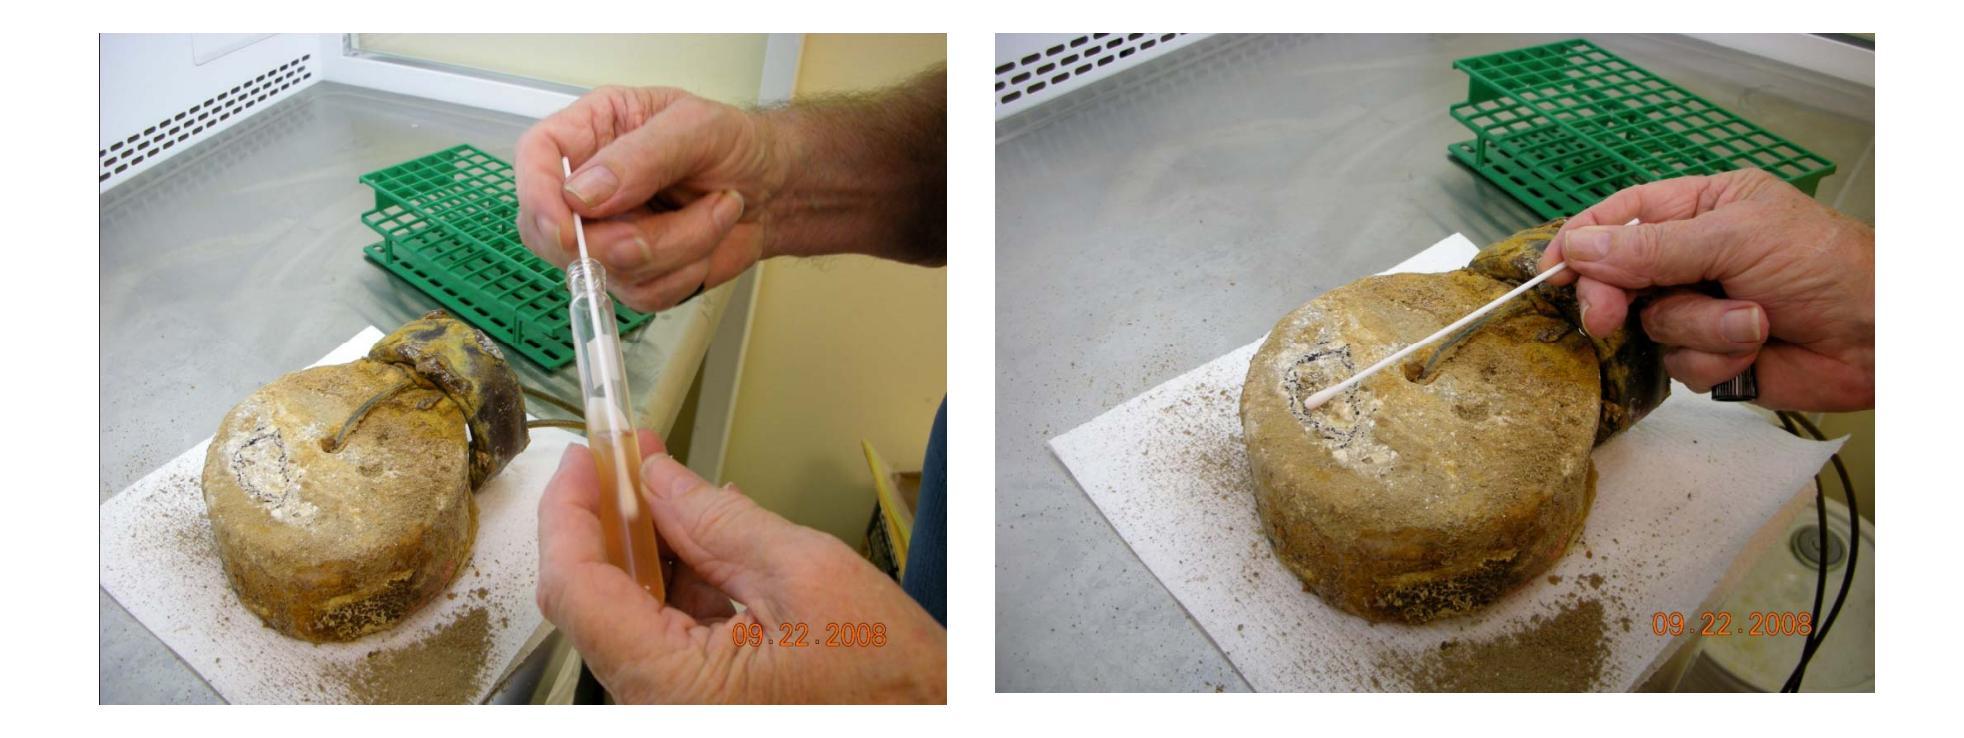
Indicator Organism Applied by swab to the test location

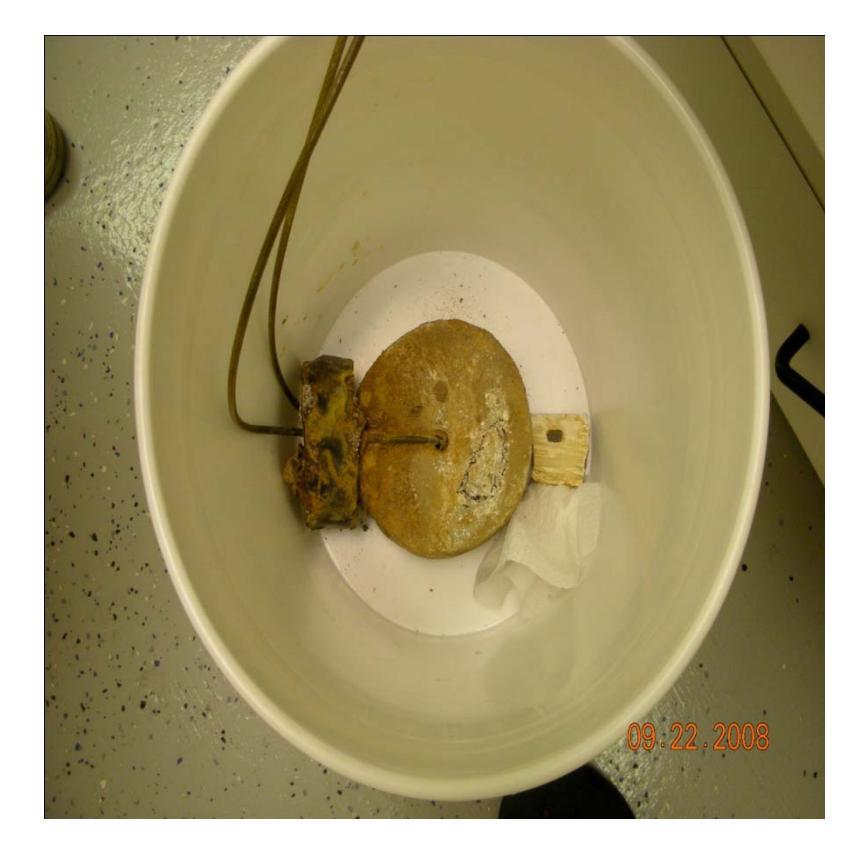
Storage for Test

The test was stored in a humid, moist area. Wet towels are used to maintain moisture. The container is then covered.

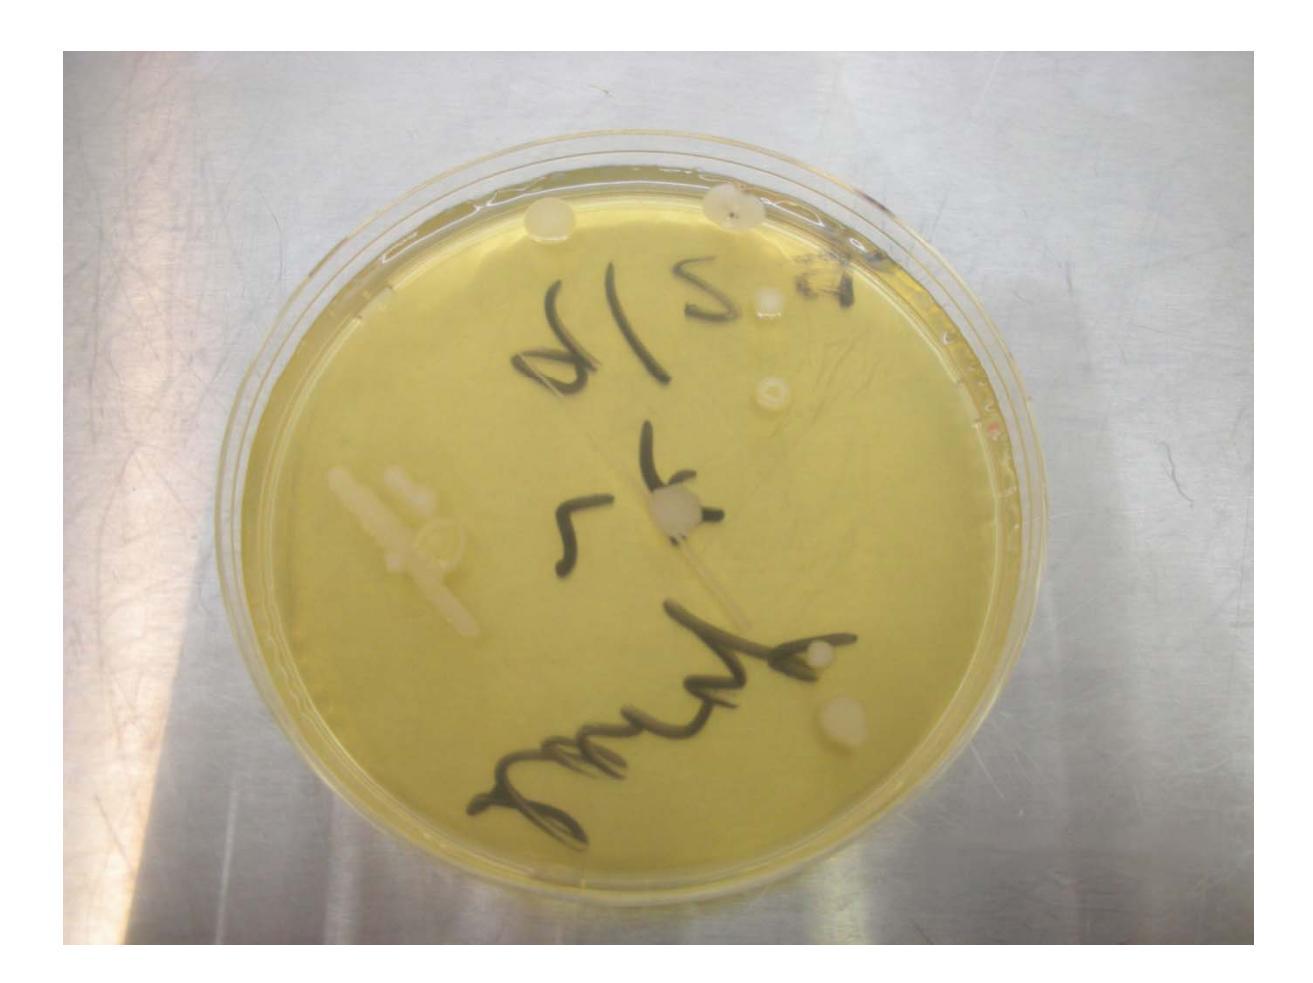
Lab Results

Test on concrete surface after alcohol scrub:

POSITIVE

- A positive result indicates that the antimicrobial was present in the sample in enough quantity to inhibit the growth of the indicator organism.
- A negative result indicates that the antimicrobial was NOT present, or it is not present in quantities strong enough to be effective.
